Apple Lisa Computer Technical Repair Information

APPLE LISA COMPUTER REPAIR INFO

Part 2 of 2

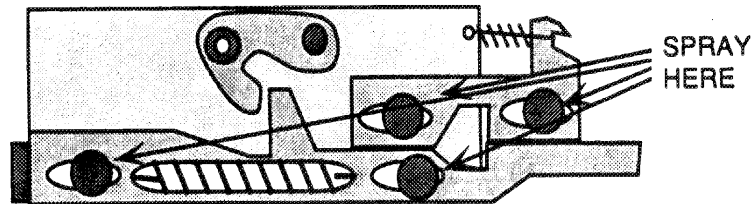
Figure 21 Spray away the old grease with WD-40.

12. WD-40 both removes the old grease and relubricates the drive. No additional lubrication is necessary. Reverse steps 8 through 1 to reassemble the repaired disk drive.

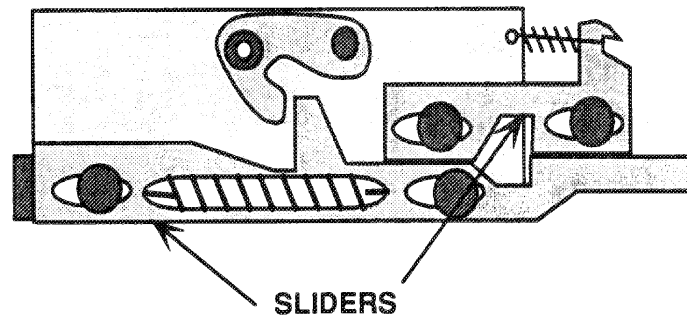
Figure 22 Work the sliders back and forth until all of the old grease is gone.

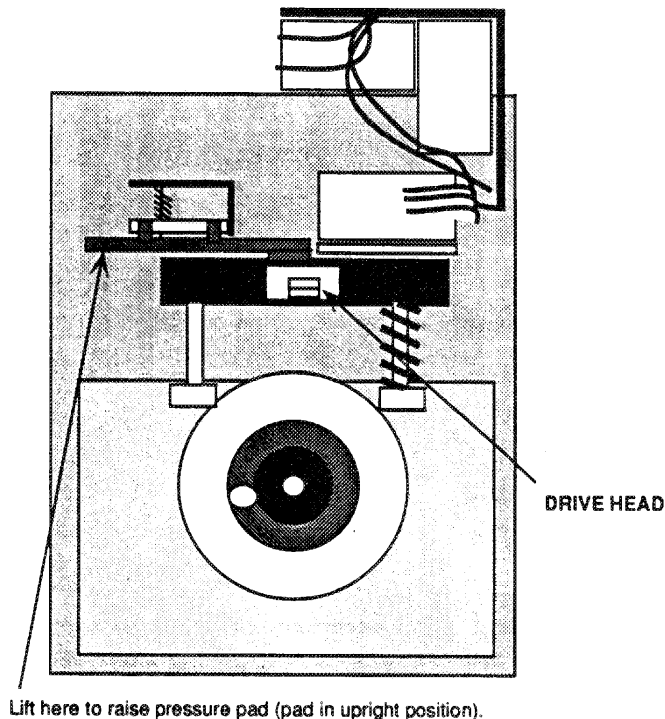
Grinding from the disk drive indicates a dirty stepper cam, a dirty head, and / or a clogged pressure pad. Clean the cam shaft with cotton swabs and WD-40, but don't loosen the cam retaining screw. Dirty heads should be cleaned the same as tape recorder

Figure 23 For easy access to the 400K drive head, pull back the pressure pad assembly.

heads. For easier access, pull back the pressure pad assembly as shown in Figure 23. Use a cotton swab moistened with tape head cleaner.

The pressure pad is made of a cotton-like material. Brush it clean with a small lint brush. If none is available, flick the surface with your fingernail. Depending on the age and condition of the drive, be prepared for a surprising amount of disk dust! Cleaning fluids should be avoided; they tend to be absorbed.

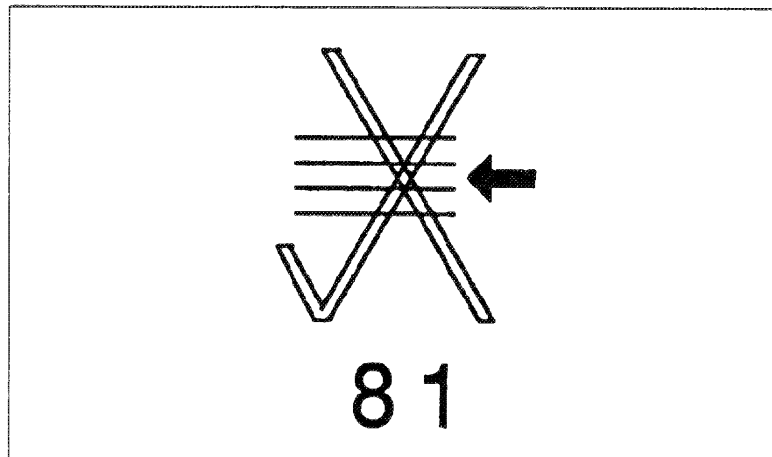
Startup error code 81 pertains primarily to the Lisa 2/10 and the Macintosh XL. Both models have a 10MB internal hard drive equipped with an electric brake. On startup, immediately after completion of the module tests, the electric brake makes a distinct clunk. If there's no clunk, it means the brake froze (didn't release). If the brake freezes, the hard disk can't spin; the result is a cross over the internal drive icon with error code 81 as shown in Figure 24.

Figure 24 Error code 81 indicates a problem with the brake solenoid.

Without further information, many people assume that they need a whole new hard drive. Rather than spend the money, they shelve the computer. Well, it's time to dust them off! Error code 81 simply means the brake is out of adjustment. You can fix it, easily, in under an hour, with a #1 Phillips-head screwdriver and a .012-inch feeler gauge. Here's the complete procedure:

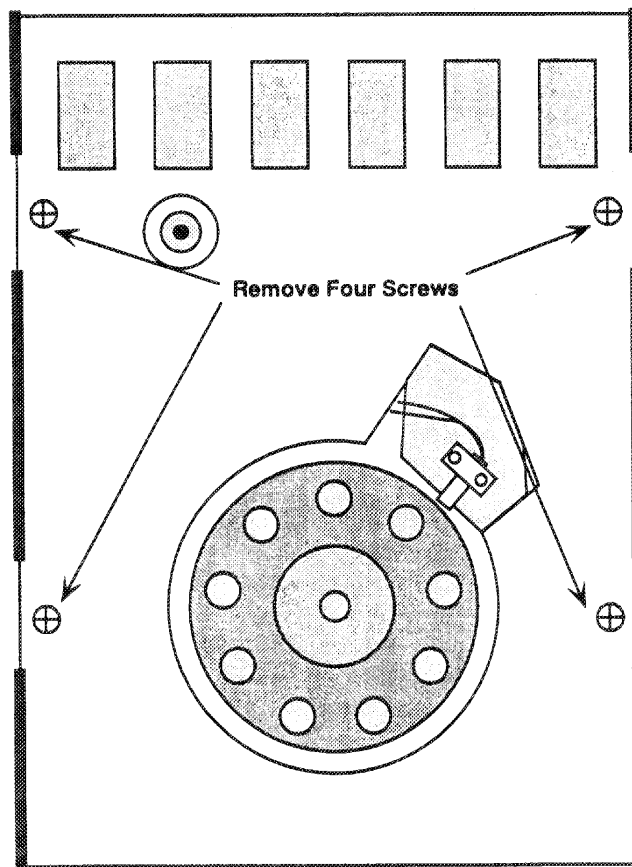
Figure 25 Four screws hold the sheet metal support bracket.

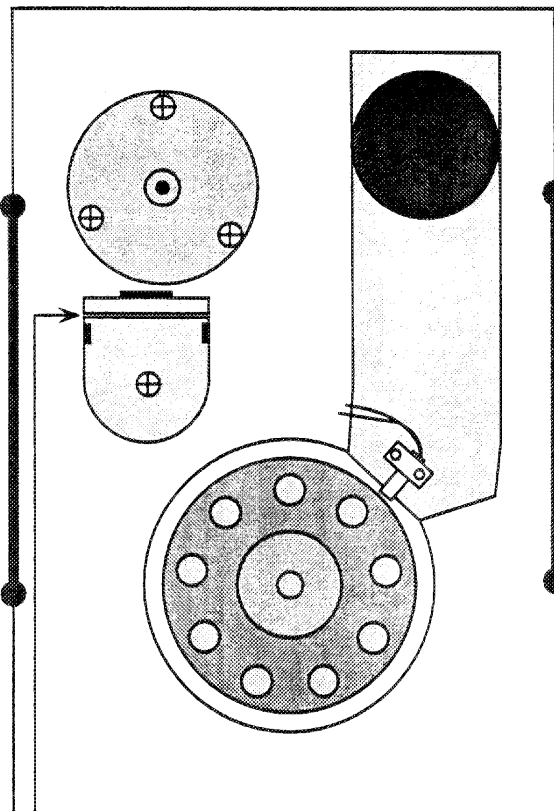
Figure 26 Adjust the brake with a 0.012-inch feeler gauge. 9. At the time of failure, clearance might be as much as 0.075 inch. Loosen the solenoid holding screw and adjust for 0.012-inch clearance.

Tighten the screw, reverse steps 7 through 1, and everything should be OK! If not, repeat steps 1 through 9, allowing a little more or a little less clearance, until you get the brake working.

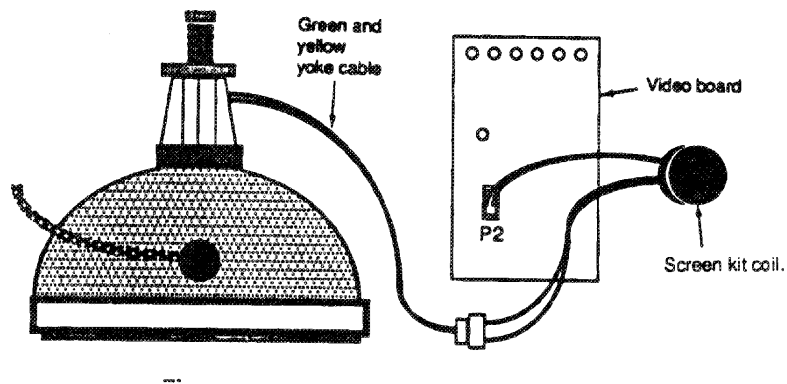
Figure 29 XL screen kit wiring details.

12. Unplug the green and yellow CRT (yoke) to P2 cable from the video board. As illustrated in Figure 29, P2 is located

- approximately halfway down the left side of the board.
13. Plug the yoke cable into the new screen kit transformer. Plug the new transformer into P2.
 14. The new transformer attaches to the outer wall of the disk-drive chamber with double-sided tape. Clean the area, and attach the transformer as shown in Figure 30.

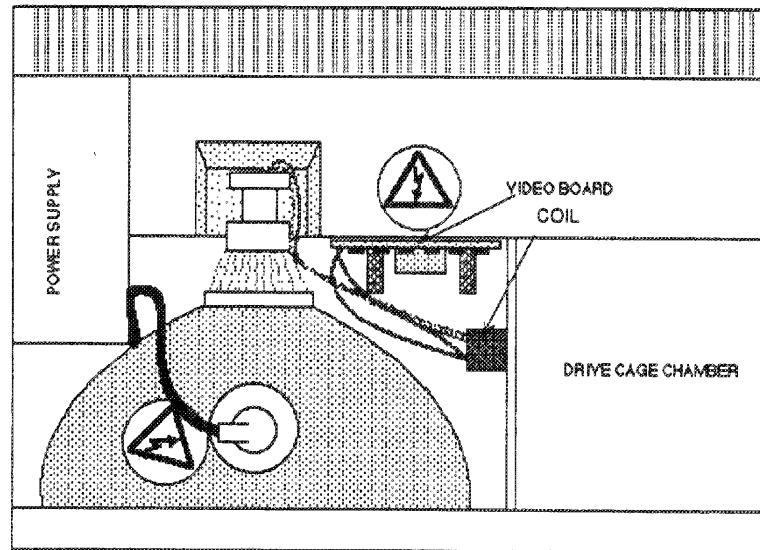
Figure 30 The new coil attaches to the outer wall of the disk-drive chamber with double-sided tape.

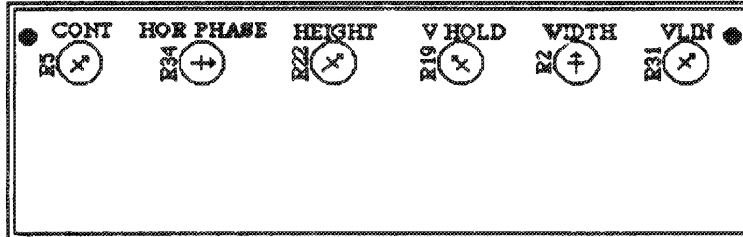
Figure 31 The CONT., HOR. PHASE, HEIGHT, V. HOLD, WIDTH, and V. LIN adjustments are at the top of the video board.

15. Locate the six adjustment potentiometers labeled "CONT.," "HOR. PHASE," "HEIGHT," "V. HOLD," "WIDTH," and "V. LIN" which are at the top of the video board. As shown in Figure 31, these adjustments have been sealed at the factory and will have to be unsealed and readjusted for use with the screen kit.

16. With a sharp razor knife, carefully remove all of the sealant. The key word here is all. It's not enough just to break the sealant. Any glob that remains may artificially limit the adjustment, making it impossible to properly realign the screen. For best results, every glob of sealant must be removed!

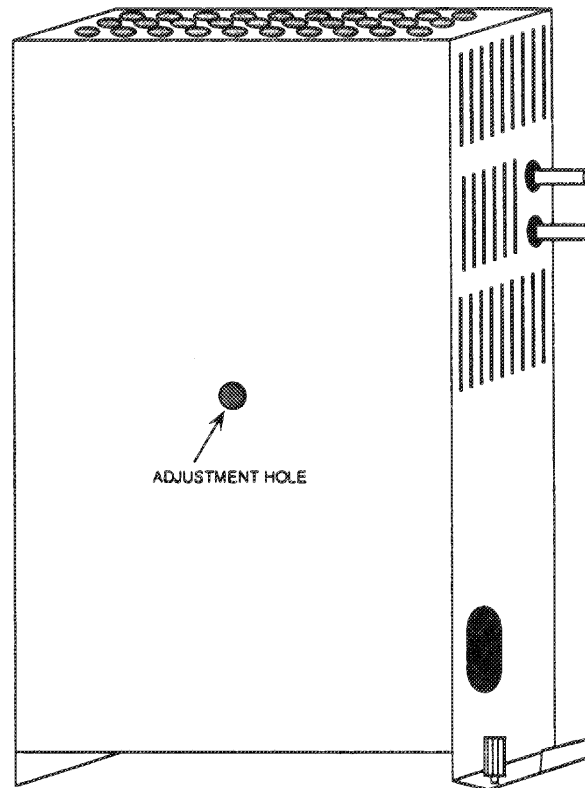
Figure 32 The +5.00-V adjustment can be reached through this access hole on the left side of the power supply.

20. As shown in Figure 32, find the access hole on the left side of the power supply. With a long-handled 1/8-inch slotted screwdriver, tweak the +5.00-V adjustment pot (R11) clockwise 1/16 of a turn. Reinsert the supply and measure again (repeating step 18). If the meter still doesn't read +5.00 volts, repeat steps 18 through 20 until it does.

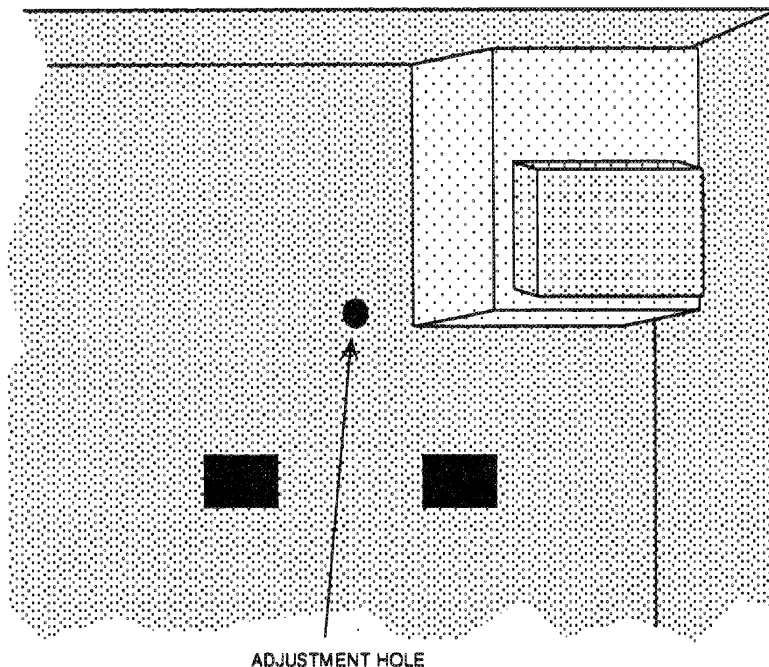
Figure 33 L3, the coarse width control, is located below the alignment pots and has to be tuned from the back side of the board.

22. Boot MacWorks or MacWorks Plus. Measure the screen size. Don't be surprised if you have to turn both controls fully counterclockwise (to approximately 8 o'clock). The final raster should measure exactly 8.44 inches in width and 5.99 inches in height. If it's substantially larger than that, shut down the Lisa /XL and remove the power cord . Pull the card cage, observe the metal chassis and find the L3 (coarse width) access hole. As shown in Figure 33, L3 is located below the alignment pots and has to be tuned from the back side of the board. Insert a plastic hexagonal alignment tool through the access hole and turn L3 counterclockwise (in), one full turn. That should do it. Reinstall the card cage, reboot, and repeat the HEIGHT and WIDTH adjustments for best linearity.
