Apple Lisa Computer Technical Repair Information

APPLE LISA COMPUTER REPAIR INFO

Part 2 of 2

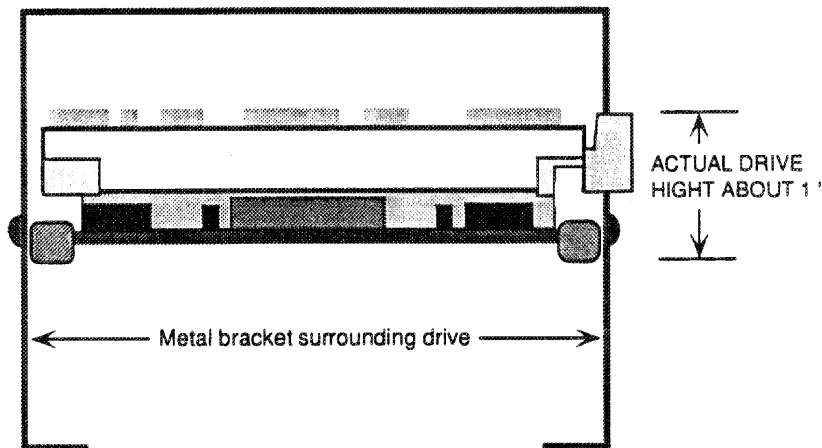
Figure 27 Profile view of an 800K drive in the mounting bracket. It takes up about half the room as a 400K drive

The 800K disk drive upgrade includes a new 800K disk drive, exactly the same drive that comes in every other Mac, a new disk drive ROM chip, the latest Macintosh System software, and the latest version of MacWorks Plus. All you need is a #1 Phillips-head screwdriver to install the drive and a small flat-head screwdriver to install the ROM. Figure 27 shows an 800K drive installed in a Lisa 2/5.

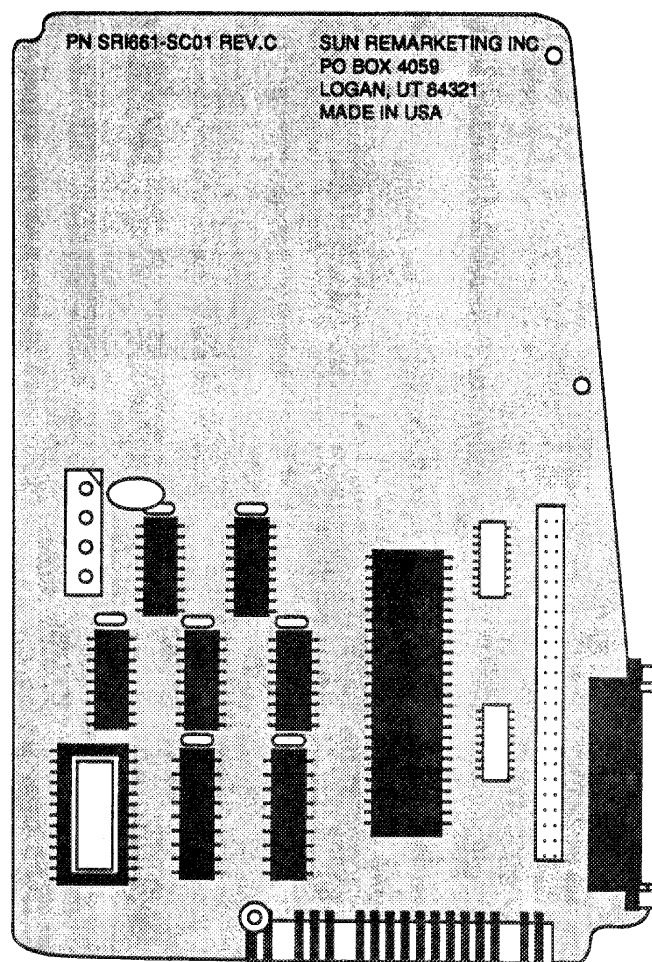
Figure 30 SCSI card for the Lisa/Mac XL.

Through the years several hard drive options have been available. New technologies in both operating systems and the hard drives themselves make one option optimal, the Sun 40 SCSI. The Sun 40 SCSI is a true SCSI hard drive mounted on a SCSI card (see figure 30) that fits internally in the Lisa or Mac XL via one of the expansion ports. The SCSI card also allows you to connect external SCSI devices to your computer as well.
